Identify and submit the tile restoration plan for Sheikh Safiuddin Tomb Collection

Keywords: Tomb of Sheikh Safiuddin Ardebili, tiling, technology, pathology, restoration plan

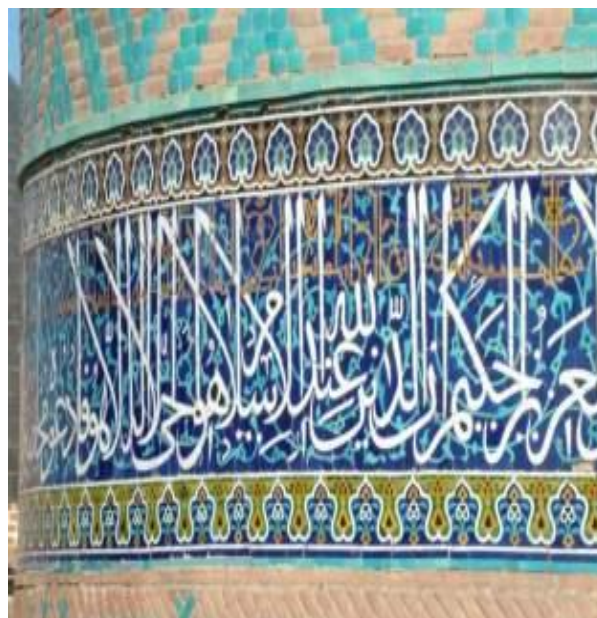
At the end of the Ilkhani era and the beginning of the Timurid era, the tile art with a history of about three centuries appeared to be the most beautiful form of the tile of "Mareq". The art of tiling mosaic or tile flower and bush, which is more famous for mosaics with Europeans, has gradually become an adornment of Iranian architecture, especially religious buildings, since the seventh century AH. The importance of mosaic tile to other types of beautiful tile is its degree of strength. To make a mosaic tile, first tile is cut into small pieces or large pieces, and according to the previously prepared map, they fill the pile and then fill with gypsum droplets and joints, so that all of it becomes integrated into a tile piece and when Which is tight, installs it on the building. Various colors were applied in the mosaic tile, in which white, dark blue, turquoise, green, orange were more visible. The tiles used in Sheikh Safi-al-Din Ardebili's Tomb are more than tile mosaic, including inscriptions, mud-plant designs, header lattices, etc., for example, in the southern side of the dome of Allah, Sample There are various works of tile mosaic such as geometric designs, slabs, mogharnas, pencils of the inscription with the third line and koufi jokes, etc. Another design is visible in their bit and it is a combination of tile with bricks that tile mosaic With elegance, the more complete it comes with the brickwork of beautiful geometric designs.

Figure 3. Sheikh Safi al-Din Ardebili's Mosaic Tile (Writer)

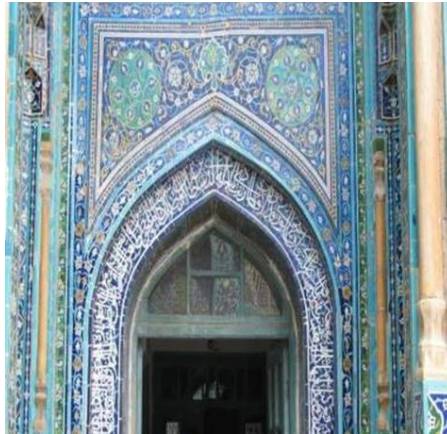
The screw contained in the Sheikh Safi Tomb port is molded on a mold with flowers and bushes.

Figure 4. Sheikh Safi's Tombstone Tile (Writer)

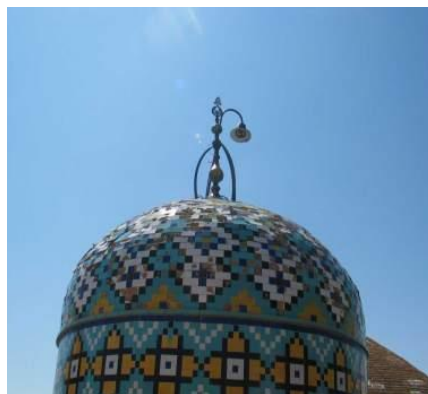
The family is a mosaic tile. But the mosaic tile is easier and more affordable. The tile used is the same 15x15-tile tiles used in mosaic tiles that are cut to the desired size. (Of course, these slices should be true) Slim and thin designs are not applicable. And only geometric shapes are applicable to it. Of course, the building lines are also written. If bricks are used, glazed bricks or tiles are used and this is done at the right angle. In the name of Maqali is famous and it can be said that "some graffiti of materials such as brick and tile (separated and dashed) are made. Its application is in Sheikh Safiuddin Ardebili's Tombstone Collection, which is the stem of Shah Ismael's Gonbad, which you can see in the picture below.

Figure 5. Gonbad Shah Ismail's Tile (Writer)

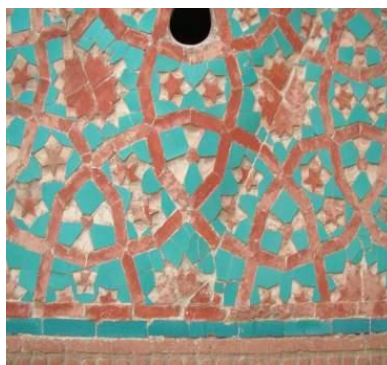
In the category of mosaic tile is a combination of tiles and bricks. And they create different Indian forms. Both prominently and equally applicable. In Chinese knot, designs such as Slimy, Khatami, etc., which are widely used in mosaic tiles, are not possible. The Chinese knot is used in the tombstone in the stem of the dome, which is shown in the picture below.

Figure 6. Chinese Dome Tower Tile (Writer)

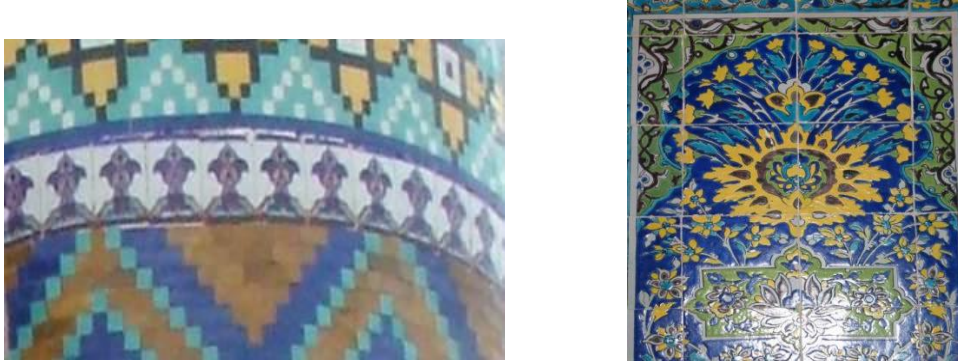
From the end of the Timurid period and the beginning of the Safavid period, the use of another type of tile known as "Adhesive" or "Seven Colors" was used to decorate various buildings. The application of the "seven colors" tile, which has been used since the end of the Timurid period in different buildings, continued until the Qajar period. The seven-tone tile, which has a lot of reputation, is from the four-tier clay tile, measuring 15x15x5 inches. They paint the desired role on it and heat it to the slave furnace to cook the glaze. Then the furnace is installed and mounted on the wall. Seven colors are commonly used: black, white, azure, turquoise, red, yellow and banana, which are used in historical buildings and places of this type of tile. Used in a tile of seven colors in the tomb of Sheikh Safiuddin Ardebili are the lower parts of the Chinese house. (Among the tiles of the seven colors used in the tombstone, even 20 x 20 dimensions can be seen.)

Figure 7 and 8 - The seven-color tile of Shah Ismael dome (Writer)

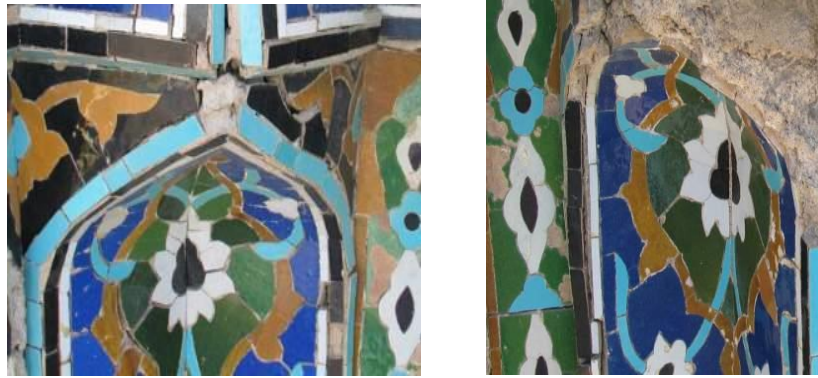
Some of the used tiles have lost their glaze over time and have left their glazes inadequately, due to the poor quality of the tiles, the influence of moisture on the underlying layers, and the lack of proper selection of tiles and glazes. .. have been . Of course, the difference in night-time temperature in the area should not be ignored. It should be noted that most of these damage are seen in green and azure tiles.

Figure 9 & 10 - Glazing (Writer)

What the organization policy is about decorative tile works, especially architectural decoration, has been the advancement of a protective system and, as far as possible, avoiding the rebuilding of the century's recommendation. Therefore, considering all the cases regarding the tile works of Sheikh Safi's tomb collection, including the place in question, it is strongly recommended to continue the process of reflection. With the study, at least 55-60% of existing tiles can be used and the remaining parts are filled in with new tiles or gijks, and finally, by creating a pattern on them and using the color of watercolor, and In the end, in order to avoid moisture penetration, a critical factor in the tiling freezing process is to be coated with hydrophobic resins.

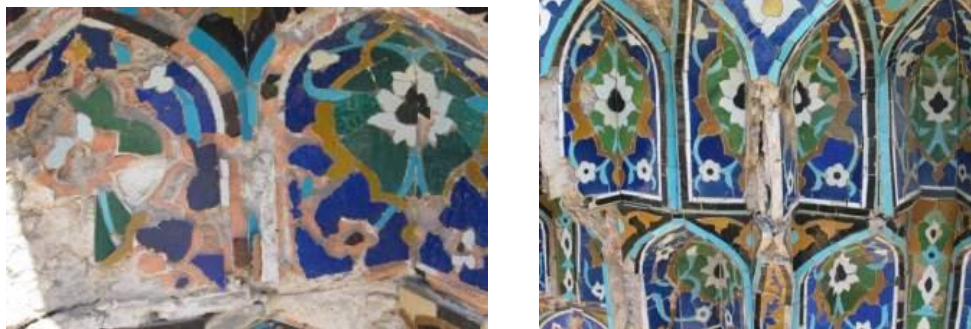
In many cases, in addition to the glaze, the tiled part of the flower was lost. As for A, the main cause of this lesion is the selection of raw materials, as well as the atmospheric and geographical conditions of the site.

Figure 11 & 12 - Tile Blossom (Writer)

In the case of tiled tiles, it is sometimes seen that parts of the tiles, especially the edges of them, have been lost. If the new tile is not possible, these tiles, if left intact, will be a good place to penetrate the moisture to the back. Therefore, it is suggested in the first step that the use of such tiles can be avoided as much as possible, but if necessary, re-use these tiles should be done at the end of the work, in comparison with the insulation of the edges. For this, the use of para-white B72 or similar polymer compounds is recommended.

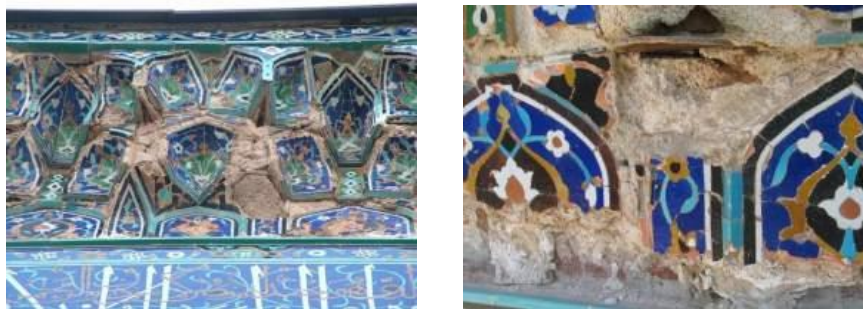
The tiles of some levels of Mogharnas are completely gone. One of the reasons for this is the lack of proper connection between the tile and the mortar, as well as the influence of moisture on the tile's back layers, and the inappropriate percentage of the mortar composition, as well as the removal of the retaining metal sheet and the further pressure on the Mogharnas and ... cited.

Figure 13 & 14 - The destruction of the Mogharnas Tile (Writer)

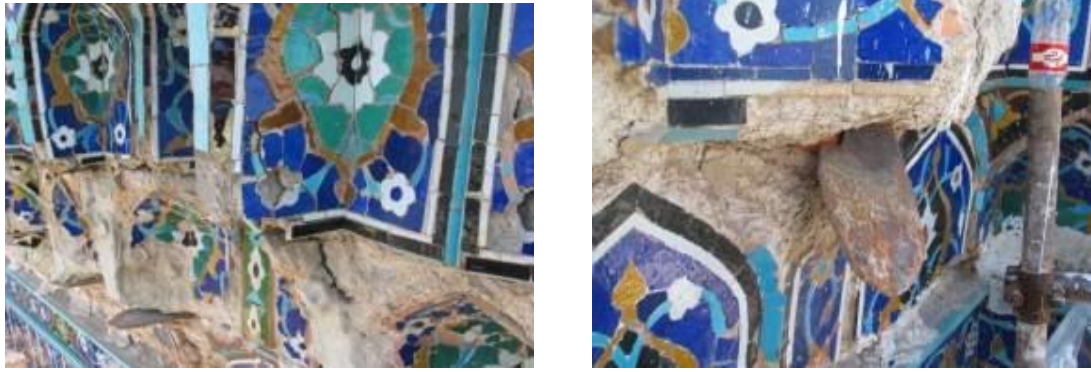
As mentioned before, one of the reasons for tile demolition and the elimination of the tile surfaces associated with the metal plate used in the main structure of Mogharnas. The iron board is heavily damaged due to the influence of moisture and rust, and in some cases it has completely disappeared. Thus, the pressure from the Mogharnas, which should have been neutralized by these surfaces, was not inhibited, and this pressure was applied to the sections Other like edges and ... has entered and caused destruction and, in some cases, hanging the edges.

Figures 15 and 16 - Laying Metal Plates (Writer)

In the case of metal sheet metal, to prevent the possibility of rusting metal (metal), resulting in increased volume and slippage at the tile surfaces, also due to the necessity of using the board and the lack of suitable replacement for it. Before installing the work piece (metal) in the areas used, it should be done to insulate them. For this purpose, it is recommended that the sheets be treated with a fine, accurate, accurate, and so on, and then their surface is removed from any additions. Finally, they should be added to the surface with the precision of all stainless steel. After drying and ensuring their insulation, install them in the desired area.

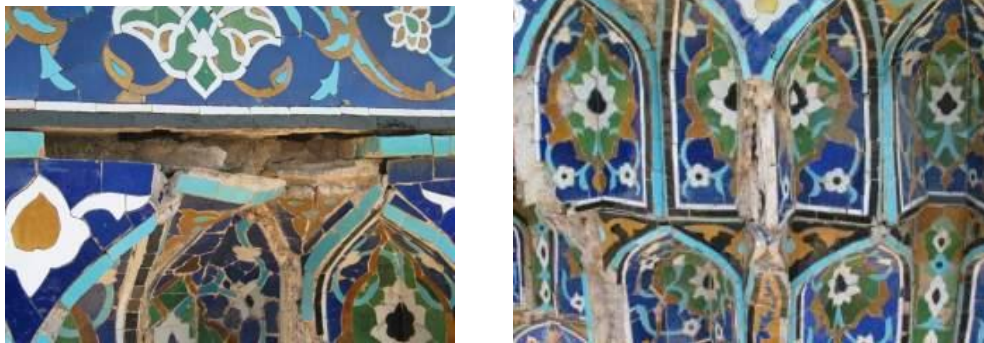
Another case of damage to the tile set used in Mogharnas is the seamless integration of tiles and, consequently, the separation of the tile layer from the gypsum bed, thus providing a suitable ground for penetrating rain and moisture to the layer. Underneath the tile and reduce the life of the tiles and the loss of gypsum mortar and The lesion is caused by different influences such as the pressure of the various layers, the loss of the metal (laminate) and the slackness of the primitive mortar, as well as the penetration of moisture from the back wall and possibly the movement and movement of the wall, and in the event of incorrect and cross-sectional repairs. Is.

Figure 17 & 18 - Tile layer separation from gypsum bed (Writer)

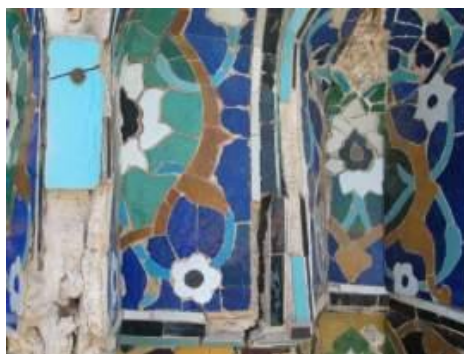
One of the important factors in the elimination of tiles and their instability is the lack of precision in the selection of improper mortar so that the selected mortar does not have sufficient stability and resistance to maintain tiles. The main reason for this can be attributed to the incorrect mixing of the mortar with excessive moisture penetration from the wall. Hence, in most parts of the tiles, there is a loss of tiles, as well as the loss of bedding.

Figure 19 - Inappropriate Mortar (Writer)

Another point to be made about the above location is the attention to the used mortar behind the work. Considering the physical conditions of the site and considering the high probability of moisture penetration from the back of the work, during the permanent inspection of the insulator behind the work and ensuring its strength (in 2004, the insulation was completed, but it is necessary every six months. The location is accurate and should be rectified as soon as possible in case of any damage). It is necessary to review the used mortar. In this regard, we propose:

Using traditional gypsum mortar, add as much as 7 to 5% volumetric gypsum to the composition, white cured whitened to achieve a relatively stable and stable mix mortar which, while being insulated against moisture penetration. In the case of moisture absorption, there is no evidence of an increase in volumes that are usually present in gypsum mortar in such cases, which will cause the tiles to be tiled and get out of the surface.

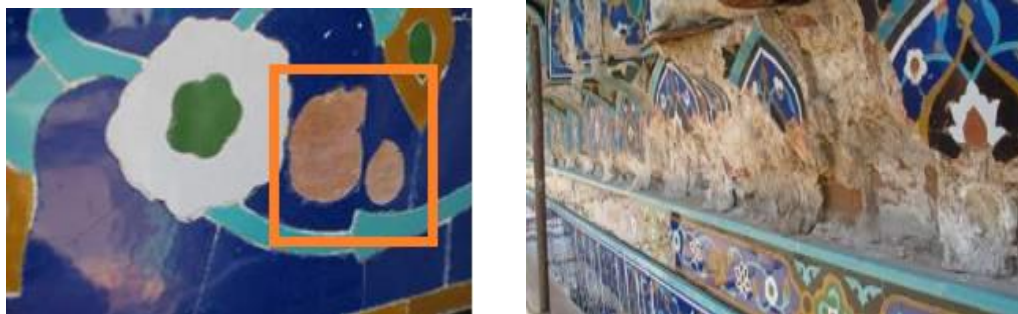
Considering the six paragraphs above and examining the damage, it seems necessary to review the status quo and make a decision on the maintenance of restoration and reconstruction. Considering that in the lower part of Mogharnas, the inscription, which is part of the Quranic ending prayer, was reconstructed in 2000, during the installation of tiles, it was necessary to separate parts of the Fu Qing section, which created a space between the levels of creation Has made this space the perfect place to penetrate the snow and rain to the back of the tiles. As shown in the images below, the moisture penetration of the newly designed tiles has destroyed the tiles and glazes.

Figure 20 - Tile drop and disappearance of bed sheet (writer)

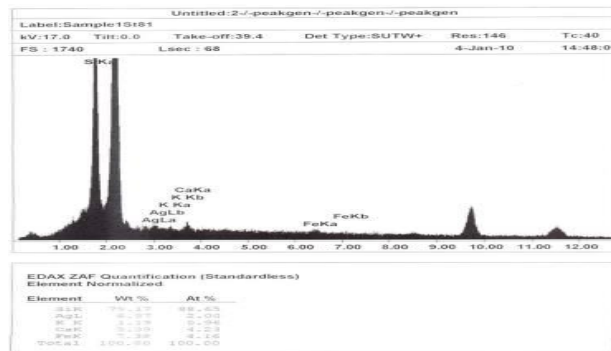
Tile structure: Determination of the percentage of elements in Sheikh Safi tombstone tile body composition by SEM analysis system. The results of the peak obtained from this system show that the tile biscuit elements have the highest percentage of their presence, including, silicon oxide 79.17 percent had the highest amount, silver oxide with 6.87 percent, calcium oxide with 5.39 percent, iron oxide with 7.38 percent, and potassium oxide with 1.19 percent lowest.

Figure 21 - Tile Body Building Compounds by SEM Analysis System

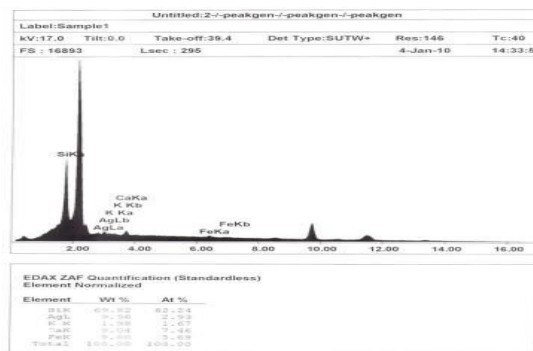
Analysis of glaze by SEM method: silicon oxide 69.82, silver oxide 9.56, potassium oxide 1.98, calcium oxide 9.04, iron oxide 9.60%. Identification of the composition and formation of porosity in the sample was one of the other materials of the study, which was carried out using the SAM system. This system identifies porosity dimensions from other experiments, such as volumetric measurements. The results of this study are shown in microscopic images taken from the sample with different magnifications. According to these studies, the size of the pores and pores in the sample was measured in several sections and with different dimensions, which on average indicates diameter: 7.83 /62.5 / 2.15 and 4.66 Micro-mm.

Figure 22- Smoothing percentage analysis (SEM)

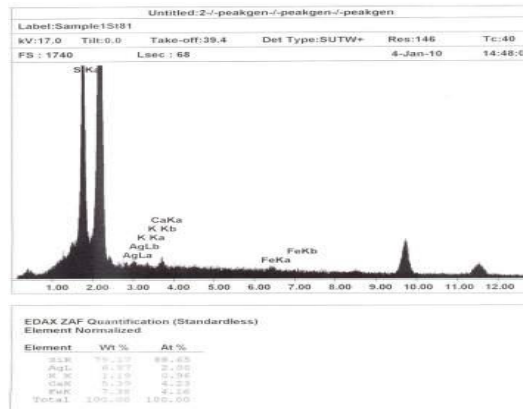
Tile structure: Identify the percentage of elements in the Sheikh Safi tombstone tile body composition by the SEM analysis system: The results of the peak obtained from this system indicate that the tile biscuit elements have the highest percentage of their presence, including silicon oxide With 57.61% the highest amount, calcium oxide with 4.05%, iron oxide with 6.63%, silver oxide with 3.50%, lead oxide with 25.18% titanium oxide with 2.43%, and potassium oxide with the lowest content of 0.59%.

Figure 23- Elements in the green tile body composition by the SEM analysis system

Based on the obtained images, it was found that the blue sample is of a single fabric texture, without cracks or fine cracks, which suggests the strength and good structure of the tiles of the Sheikh Safi monument tile. Green tile specimens do not have an integrated structure and glaze structure is cracked.

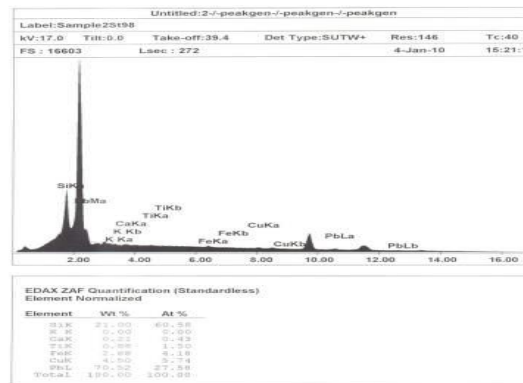
Tile glazing analysis: calcium oxide 25.00, potassium oxide 0.00, calcium oxide 0.21, titanium oxide 0.88, iron oxide 2.88, copper oxide 4.50 and lead oxide 70.52%. Identification of the composition and formation of porosity in the sample was one of the other materials of the study, which was carried out using the SAM system. This system identifies porosity dimensions from other experiments, such as volumetric measurements. The results of this study are shown in microscopic images taken from the sample with different magnifications.

Figure 24- Green Glaze Analyzer (SEM)

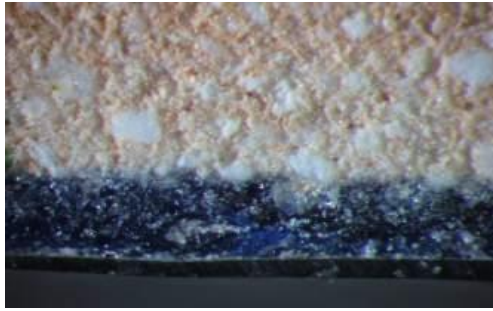
Figure 25- Silica dispersion in the water tile body

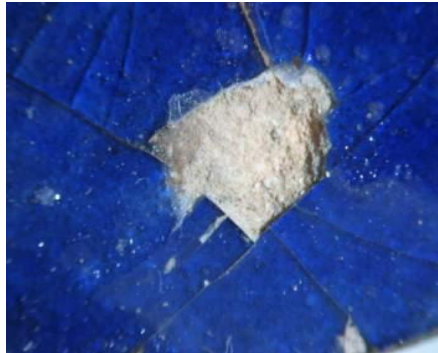
Figure 26- The presence of the crystalline structure of salts under the glaze

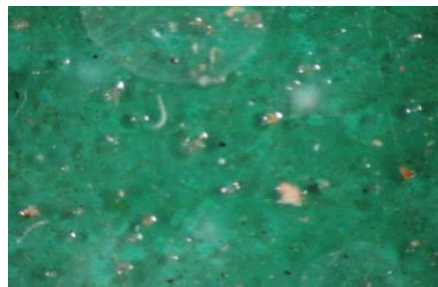
Figure 27- Glazing under the influence of dandruff

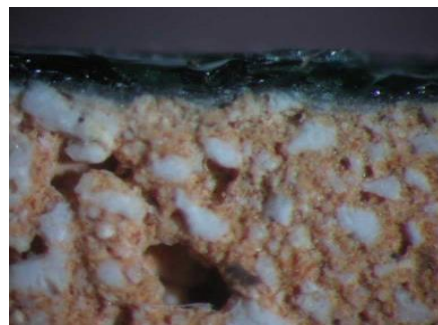
Figure 28- Silica dispersion in the body

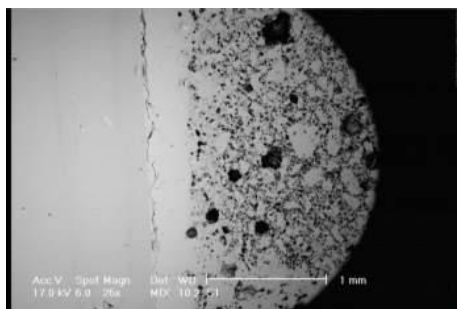
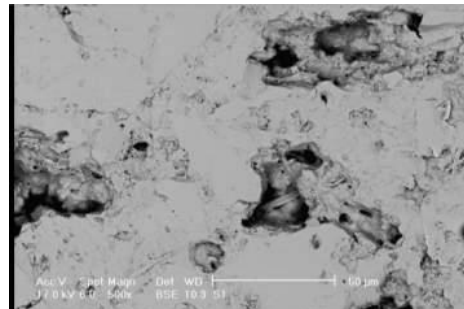
The microscope system made it possible to sample the sample in terms of drawbacks such as bubbles, their size, color variations in glazes, especially in green and blue glazes, and the quantitative changes of the elements and glaze ingredients. The results of measuring the waterproofing of the glaze by the device showed that the average thickness of the glaze layer in tile tiles is 350 µm and the thickness of the green layer is 262 µm.

Figure 29 and 30 -Installation of the internal structure of the tile body and the thickness of the glazed tile green by the sem method
